**Partial Building Defects Survey Report**

**Basement & units 1,2,3,5,6 & 7** (bathrooms & balconies)

**Rose Bay**

**The Owners Corporation**  
Strata Plan No 67XXX

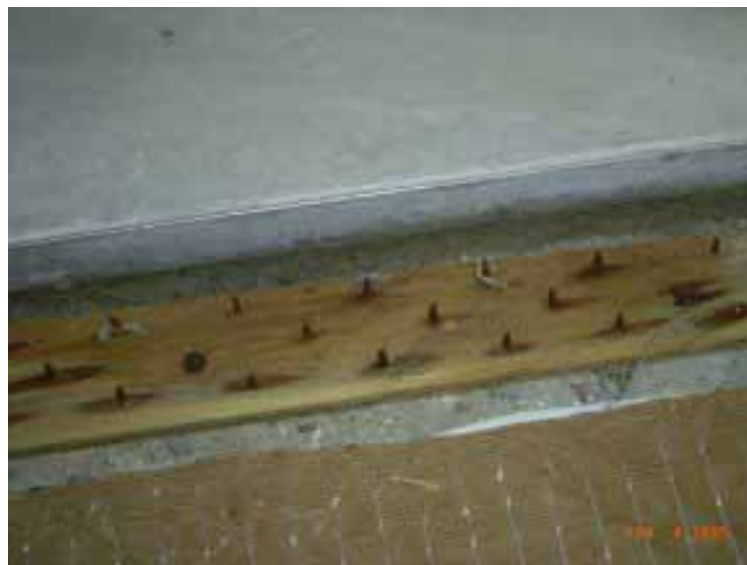
**Photo No20A**

**Damp;** there was visual evidence of moisture related staining to the tile grout outside of the shower area and moisture meter testing of the tile bed (outside of the shower area) and at the bathroom entry, recorded high moisture readings. It was further apparent that some moisture had seeped down onto the carpet and smooth edge (@ bathroom entry) causing moisture related staining to the rear face of carpet and mild rusting of the nail fixings and lower metal door jamb *Refer example Photo No20A at pg 22.*

In my professional opinion the unacceptably high moisture content within the tile bed (outside of the shower area) and the apparent seepage that is occurring at bathroom entry would be due to moisture migration out side of the shower area, due to either the lack of and/or a defective 'water stop'.

Rectify inadequate falls (to prevent unacceptable pooling) and install 'water stop' that projects above the floor tile surface. Rectify damaged carpet and rust paint treat lower door jamb.
