**Purpose of Report:** *New Unit Final Building Survey & Defects Report*  
**Date of Inspection:** 29.3.2006  
**Property Description:** **3 Bed Split Level Penthouse**  
**Address of Property:** **Unit Northcliff St Milsons Point**  
**Building Consultant:** Mr. Dominic Ogburn AMAIB Lic No BC 359  
*e-mail: [info@accesspropertyservices.com.au](mailto:info@accesspropertyservices.com.au)*  
Office (02) 9798 5000 Fax (02) 9225 9656 Mobile 0418 865-663

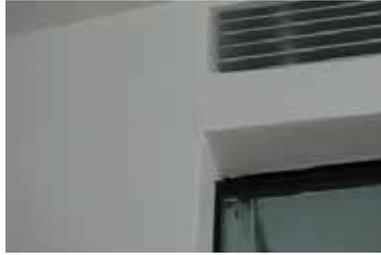
*Photo No 1*

**Bed 1;** minor differential movement cracking evident on the vertical bulkhead below NE A/C supply grille—*Refer Photo No1.*

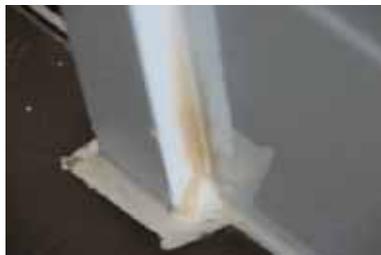
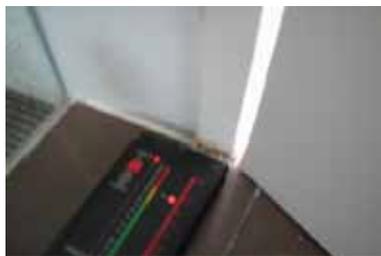
**B1 Ensuite; Refer Photos No18 & 19** showing evidence of *high moisture gain & staining* and has resulted in swelling of the lower **MDF entry door jamb**, which was moisture meter tested and recorded high moisture content in the lower NE door jamb. It is likely that this moisture gain has occurred due to a failure in the shower recess waterproof membrane / water stop system, as the jamb is embedded in the tile bed.

In my professional opinion the door jamb requires replacement and the shower area should be flood tested to determine if any leaks are still evident. Refer also Bathroom section of this report.

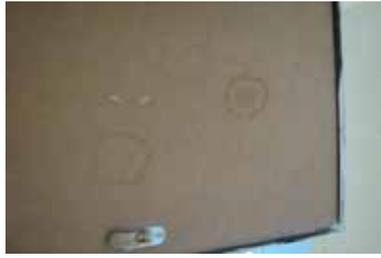
*Photo No 20*

**Lower floor main bathroom; Refer Photo No20** of prior *moisture staining* to internal face of ceiling access panel, located beneath an A/C condensate line.

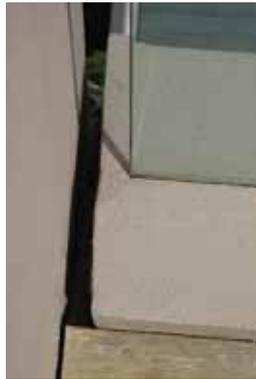
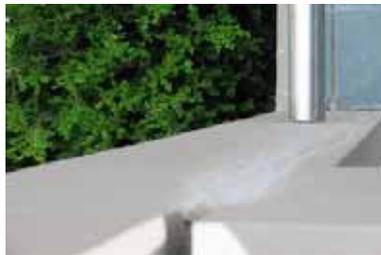
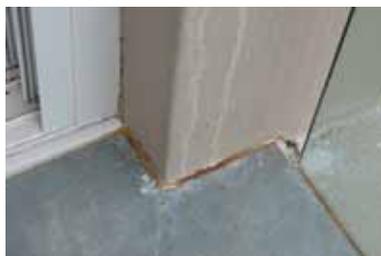
**Lower floor balcony;** Refer also marked up lower floor plan. High moisture readings were recorded in the *lower column outside Powder Rm* and in the *lower SE end wall* outside Living Rm, the upper external face of same has surface water staining, occurring due to the presence of a seeming overflow outlet (*Refer Photos No21-23*) of Bed1 deck above. Refer also 'Lower Floor Marked up Plan'.

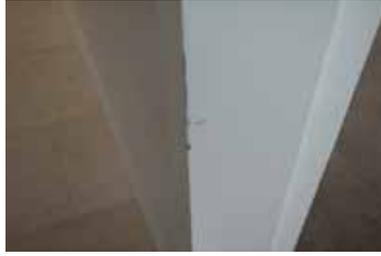
*Photo No 36*

- (2) Uneven and/ or non-matching paint coverage to the **door/ frames of *unit entry door***. Scratching evident on the external face of **B2** door jamb – ***Refer example Photo No36. B2***; inadequate paint coverage evident to the upper internal door frame.

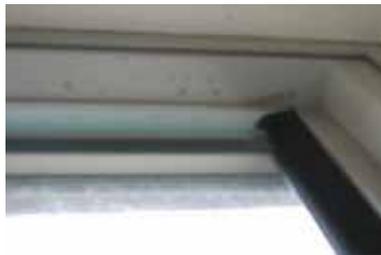
*Photo No 38*

**Bed1;** significant sealant and other stains evident to the internal frame head of SW *louvre* window (*Refer example Photo No38*)—cleanup and remove.

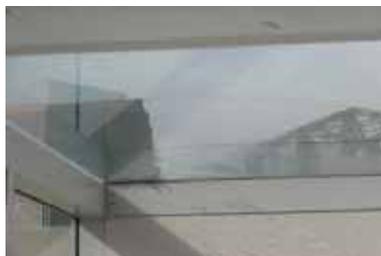
*Photo No 39*

**Stairwell;** *Refer Photo No39* showing evidence of very *significant ponding* of water on the *glazed roof* (occurred after overnight showers) and which is indicative of *inadequate falls* and will undoubtedly lead to excessive dirt buildup on this glazed roof—rectify.

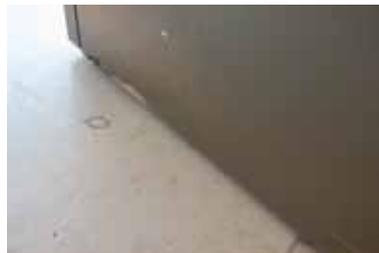
*Photo No 42*

**Unit Entry; Refer Photo No42** of **impact damage** evident to external lower veneered face of unit entry door, which requires rectification.

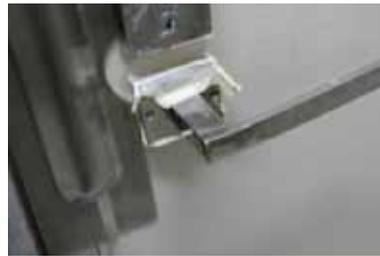
*Photo No 45*

*Living Rm joinery*, upper doors do not incorporate rubber buffers and *Refer Photo No45* of a defective single door hinge, which requires adjustment as doors are binding.

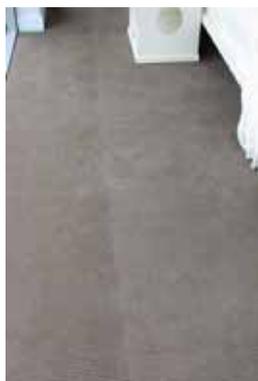
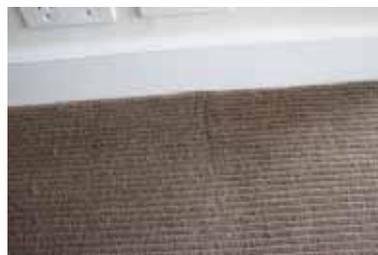
**Noted Defects;** in my professional opinion much of the carpet has been poorly laid and has *unsightly and conspicuous joins*, which is particularly evident in *Bed1* and its entry hallway *Refer example Photos No 46-48*.

All noted defective carpet joints are to be rectified such that they are not readily detectable.

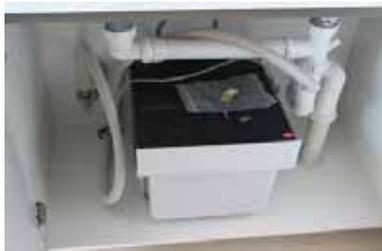
*Photo No 54*

**Noted Defects;** no under kitchen sink cupboard *mid-shelf* installed and dishwasher pipe penetration has not been adequately vermin sealed *Refer Photo No54.*

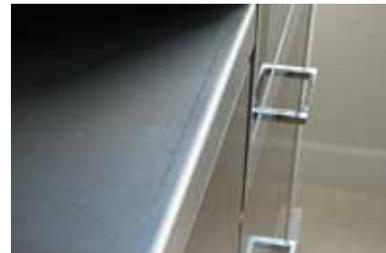
*Photo No 55*

*Refer Photo No55* of black staining evident on stainless steel benchtop--remove.

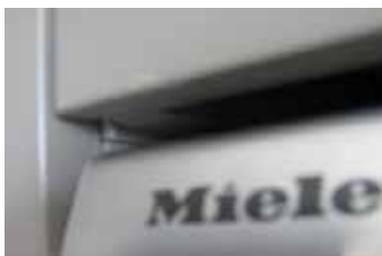
*Photo No 56*

*Refer Photo No56* of prior poorly patch repaired impact damage to polyurethane coated upper cupboard door, which should be replaced.

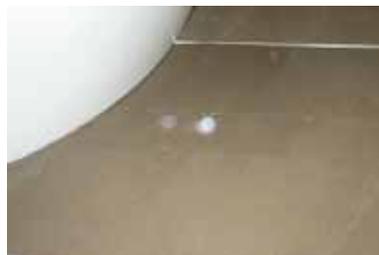
*Photo No 59*

**Refer Photo No59** showing what appears to be a **nickel sulphide type defect/**flaw in the lower external face of **toughened glass** division panel, abounding bath.

Whilst I'm not expert in glass, such flaws typically lead to fracture failure and as such I **strongly recommend** replacement with defect free glass.

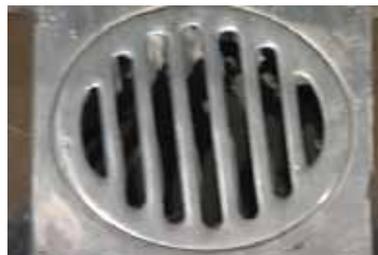
*Photo No 60A*

Remove excess sealant from floor drain grate **Refer Photo No60A.**

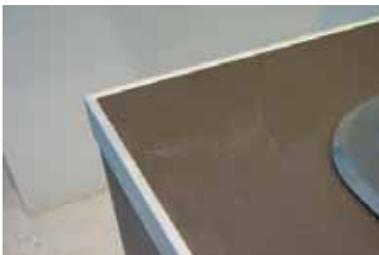
*Photo No 61*

**Refer Photo No61** showing very significant *scratching* to the laundry tub benchtop, which requires rectification. Inadequate rubber buffers to laundry tub cupboard door.
