## Common Area Building Survey Report

## S Aparments

The Owners Corporation  
**Strata Plan No X5YZ**

Prepared By  
**Access Property Services Pty Ltd**

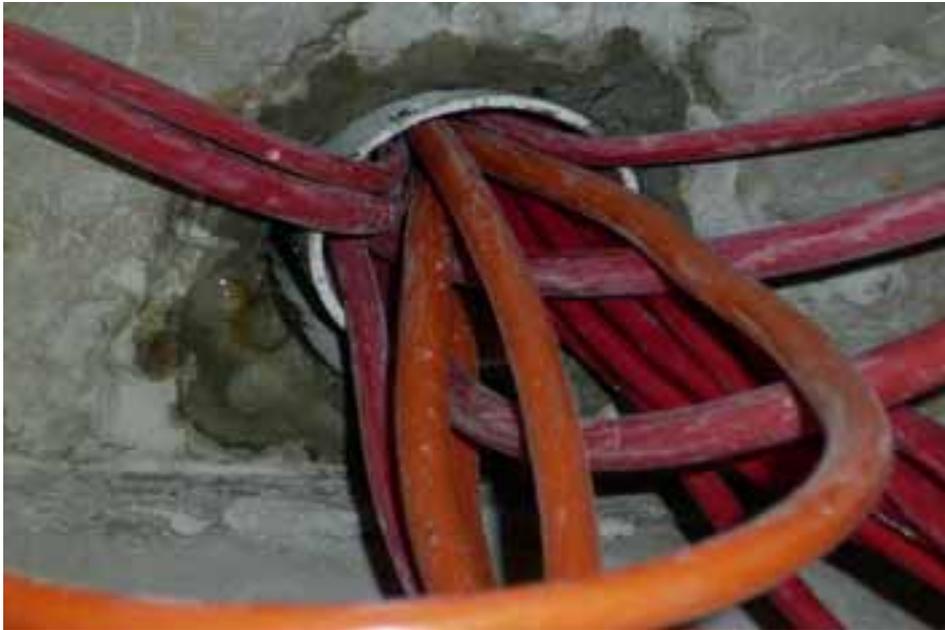
Photo No 1 (Level 15 leaks)

During my 26.6.06 preliminary inspection (during heavy rain) I witnessed **significant leakages** occurring down through the ceiling of the Level 15 slab soffit via at least one service cable penetration -- **Refer example Photos No1** and which was resulting in significant moisture related damage **Refer example Photos No 2**. The then building manager advised me that he was aware of "at least No 16 off different leaks on this level".

I **recommend** that the source of water entry through the roof slab soffit be rectified.

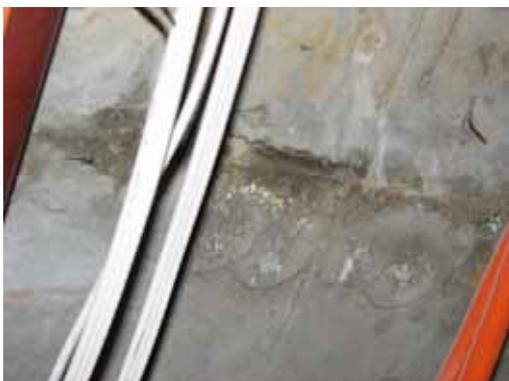
Photo No 5 (Level 15 leaks)

**Refer example Photos No5 & 5a** (taken at the central ceiling access trap outside unit No1502) showing evidence of **moisture related staining** on the slab soffit.

I tested the area with a 'Protimeter' pin resistance type moisture and recorded **high to very high moisture** content in the concrete.

In my professional opinion a leak is occurring in the roof above this area.

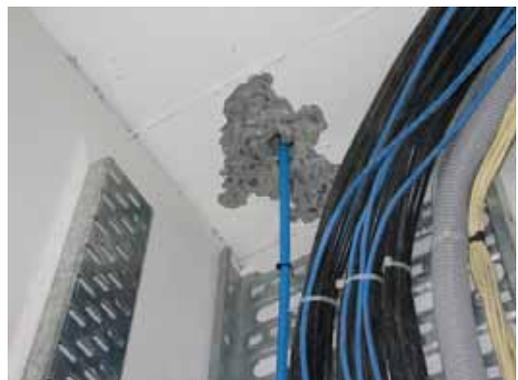
Photo No 7

**Noted Defects;** a service cable (blue) penetration in roof slab soffit did not appear to have been adequately sealed for **F. R. L.** - **Refer example Photo No7**.

**Recommendations;** I **recommend** that a fire engineer be engaged to comment further on the adequacy of vertical and horizontal fire separation issues.

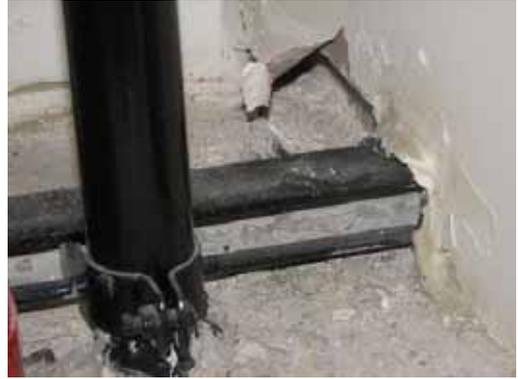
Photo No 9

**Noted Defects;** *Refer example Photos No9 & 10* showing damage to the lower separating wall and also adding adequately sealed service pipe penetration in roof slab soffit. It is possible that the F. R. L. rating has been compromised.

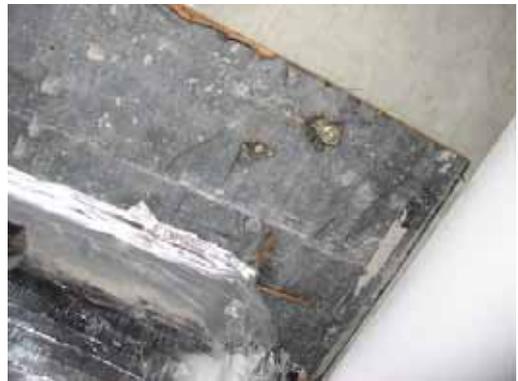
Photo No 11

**Noted Defects;** Refer **Photo No11** showing the existence of timber based plywood on the ceiling slab soffit outside unit No1409 and which may compromise the F. R. L..

**Recommendations;** I **recommend** that an acoustic/ fire engineer be engaged to comment further on the adequacy of vertical and horizontal fire/acoustic separation issues.

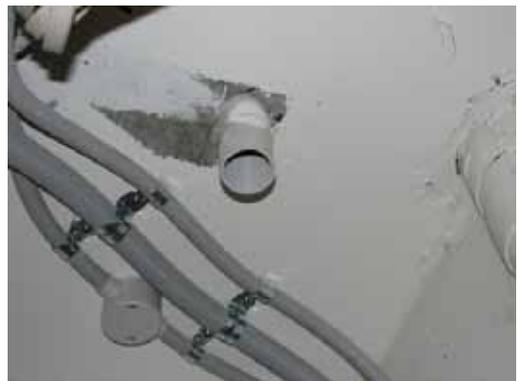
Photo No 13

**Noted Defects;** Refer **example Photo No13** (fairly typical for many floors) showing a redundant large diameter service cable conduit which does not appear to have been adequately sealed for F. R. L. It might be possible that this does not provide sufficient F.R.L.

**Recommendations;** I **recommend** that a fire engineer be engaged to comment further on the adequacy of vertical and horizontal fire separation issues.

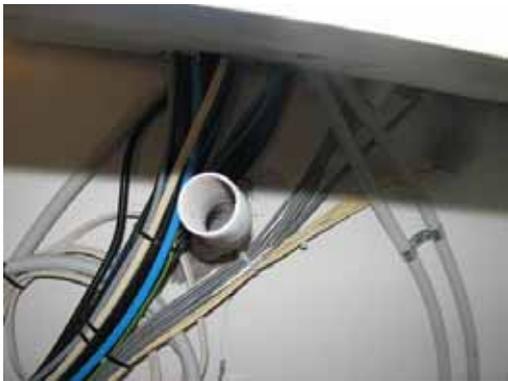
Photo No 14

**Noted Defects;** Refer **example Photo No14** (fairly typical for all floors) showing a redundant large diameter service cable conduit which does not appear to have been adequately sealed for F. R. L.. It might be possible that this does not provide sufficient F.R.L.

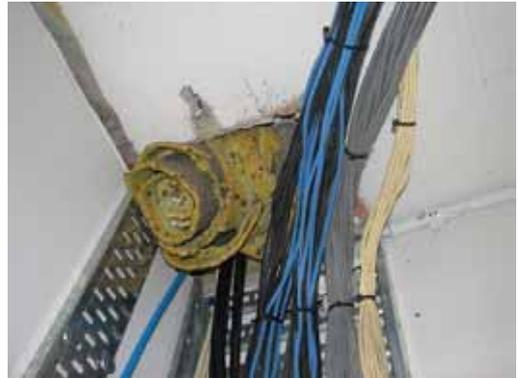
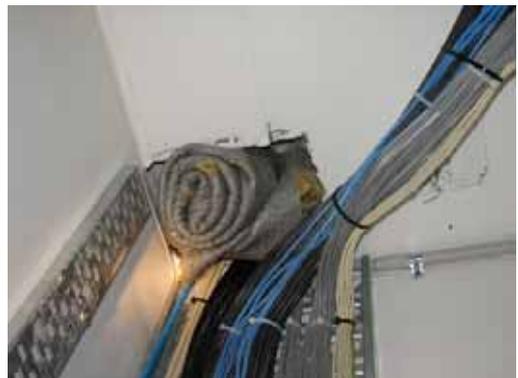
**Noted Defects;** Refer example Photos No16 – 16C of a large **service cable penetration**, which has been inappropriately sealed with a **foam-based carpet underlay** and is fairly typical of the remaining lower-level communication cupboard penetrations. It is quite possible that the F. R. L. rating has been compromised.

**Recommendations;** I **recommend** that a fire engineer be engaged to comment further on the adequacy of vertical and horizontal fire separation issues.

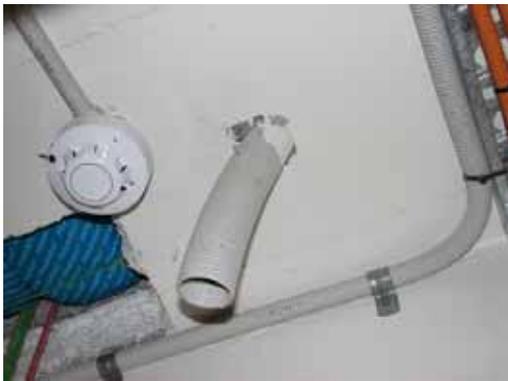
Photo No 17

**Noted Defects;** Refer example *Photo No17* of a redundant **large diameter** cable conduit, which does not appear to have been adequately sealed for F. R. L. and it is likely that the F. R. L. rating has been compromised.

**Recommendations;** I **recommend** that a fire engineer be engaged to comment further on the adequacy of vertical and horizontal fire separation issues.

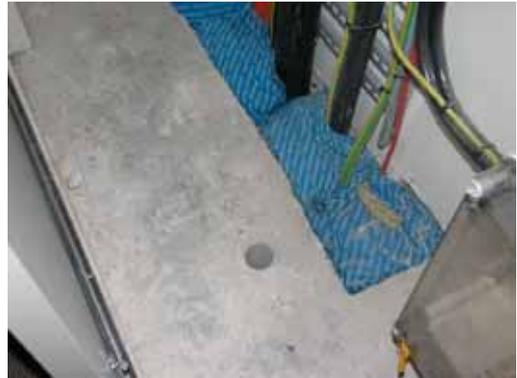
Photo No 20

**Noted Defects;** Refer example Photos No20 & 21 of a redundant **large diameter** cable conduits **penetrations** in both the **floor slab and slab soffit**, which do not appear to have been adequately sealed for F. R. L. and it is likely that the F. R. L. rating has been compromised.

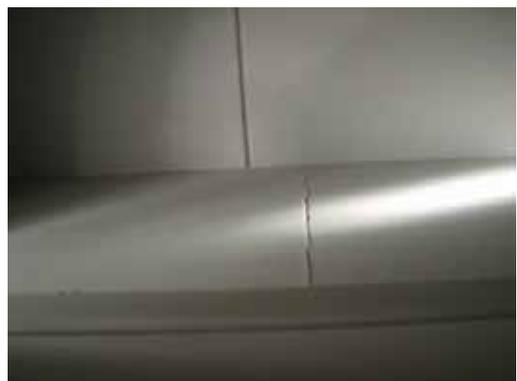
Photo No 22

**Refer example Photo No22** of differential movement cracking in the gypsum wall plaster above fire hydrant Riser cupboard, which should be rectified.

I **recommend** rectification of noted differential movement cracking within gypsum wall plaster.
