**Purpose of Report:** Pre Purchase Building Property Inspection  
**Date of Inspection:** 17.5.2006  
**Property Description:** 5 Bed Two Storey F.S Residence  
**Address of Property:** Bellevue Hill  
**Client Name:** Mr DW  
**Building Consultant:** Building Consultant Dominic. J. Ogburn AMAIB Lic No BC 359  
*e-mail:* [info@accesspropertyservices.com.au](mailto:info@accesspropertyservices.com.au)  
Office (02) 9798 5000 Fax (02) 9225 9656 Mobile 0418 865-663

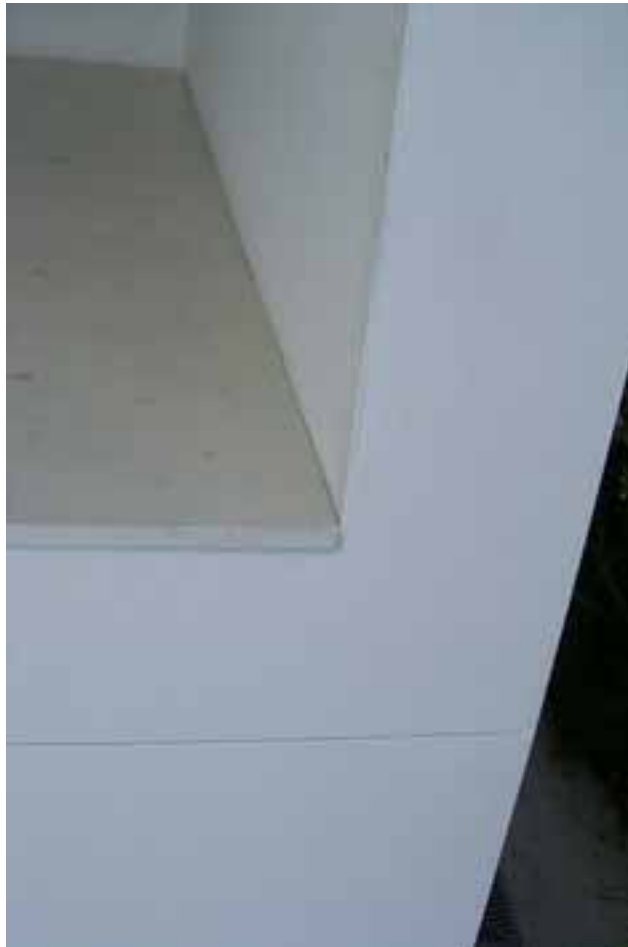
Photo No1

**External (to house) Damp**; evidence of prior patch painted high damp noted in the southern brick balustrade wall of *entry veranda*, as marked up on house plan – *Refer Photos 1 and 2*.

In my professional opinion the noted damp is most likely been caused by a failure at the wall/ floor junction of the waterproof membrane and requires rectification, which again I **recommend** be taken up with the project builders Pimas Gale for the investigation and rectification.

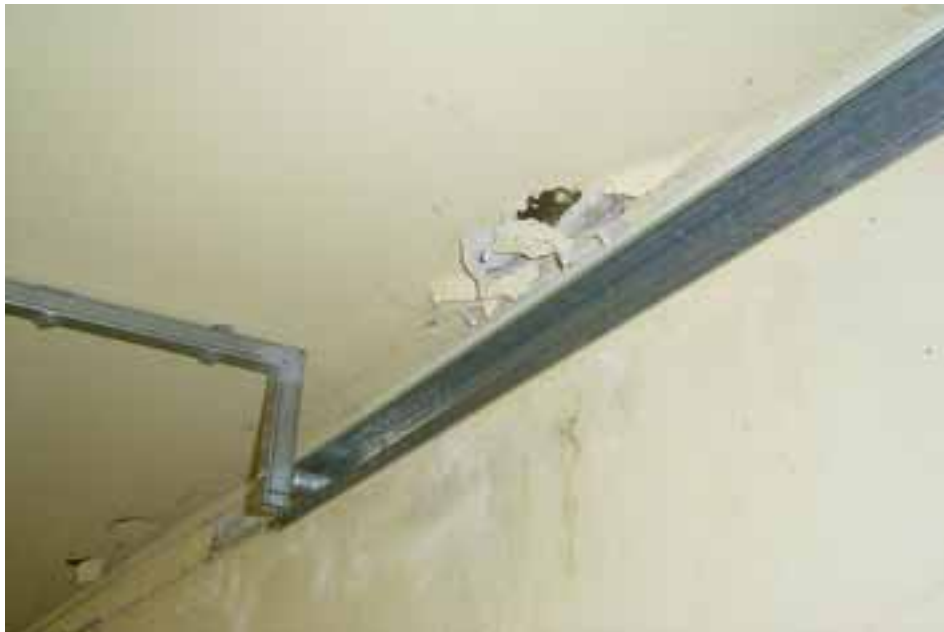
Photo No3

Significant evidence of falling damp noted that the upper **NE and southern garage walls** and slab soffit (*Refer Photos No 3 & 4*) together with aggressive efflorescence and high damp in the *external north garage wall* along with cracking in the external protective render and paint film (*Refer Photo No 5*).

In my professional opinion the noted Garage damp is most likely been caused by a failure of the waterproof membrane of the roof above particularly at the slab wall/ junctions.

I **recommend** that this damp issue be taken up with the project builders Pimas Gale for dye flood test investigation and rectification.

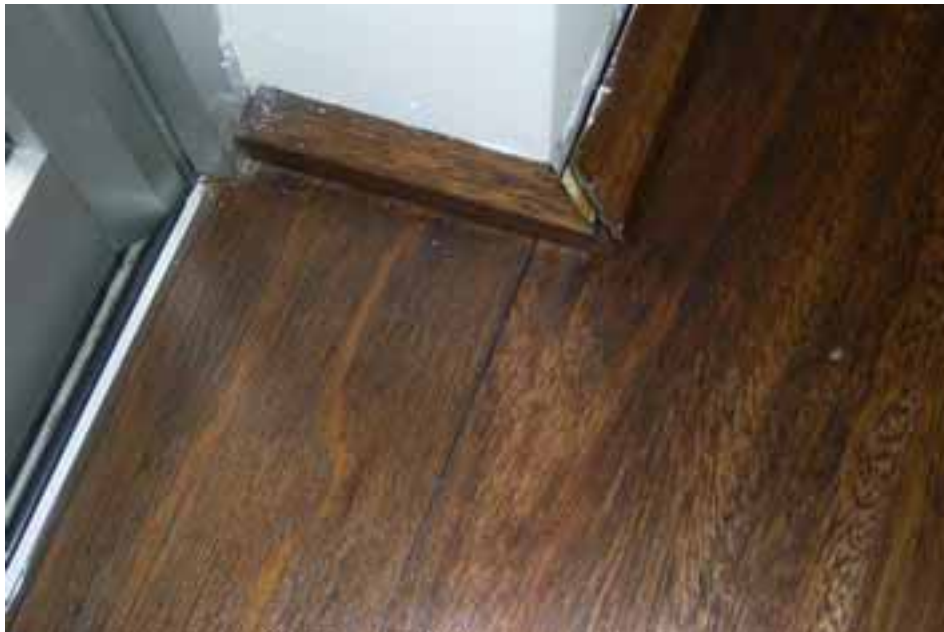
Photo No6

**Noted Defects; Refer Photo No 6** showing how a section of skirting on the northern Dining Rm wall has dislodged, which I suspect is due to inadequate expansion provision for the flooring beneath. Refer below comments.

**Noted Defects; Photo No 6** shows that a small *expansion joint provision* has been provided between the battened timber floor (which has minor evidence of cupping) and northern enclosing brick wall. In my professional opinion it is likely that inadequate expansion provision has been made and that this would have been contributory to the dislodgement of above noted skirting.

I **recommend** that this issue be taken up with the project builder for their detailed investigation and rectification.

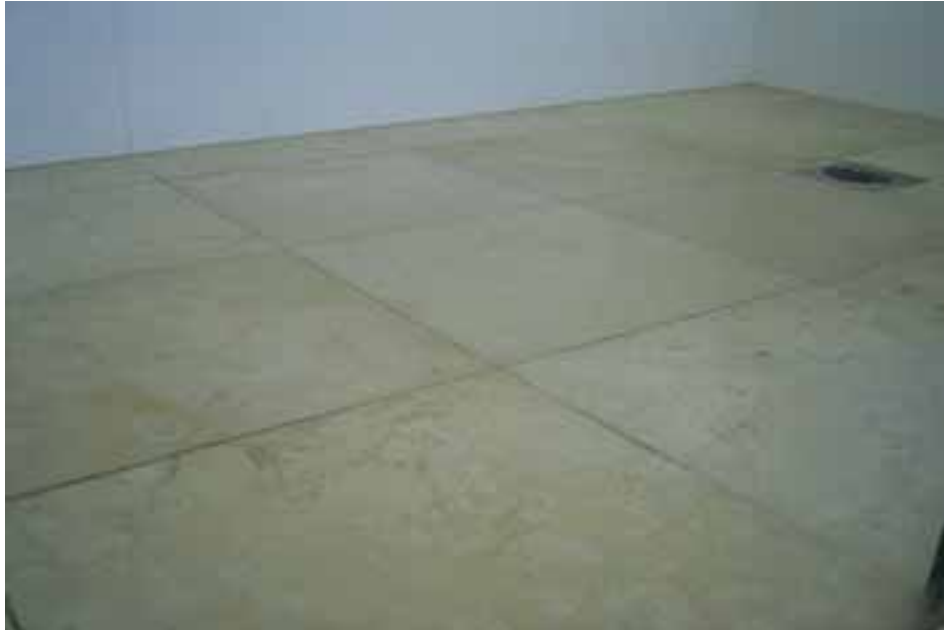
Photo No7

**Noted Defects;** at the time of my inspection *significant quantities of water or ponding* on the unenclosed shower recess floor – *Refer Photo No7.*

I undertook a basic water test and determined that further ponding occurred.

In my professional opinion the as built unenclosed shower recess is not in accordance with the minimum requirements of A.S. 3740 (at the time of construction) and that failure to rectify same could lead to loss of amenity through permanent dampness and mould promotion.

I **recommend** that this issue be taken up with the project builder for their investigation and rectification, which is likely to require the entire removal and reinstatement of the shower recess floor with special attention given to diagonally cutting tiles around shower waste.

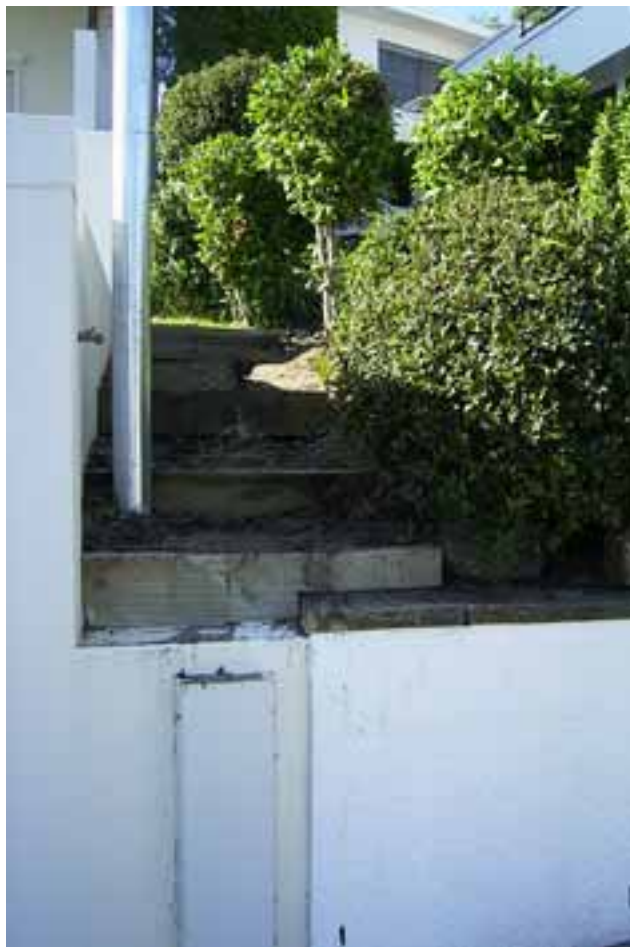
Photo No12

*Refer Photo No 12* showing significant soil erosion over the front retaining wall, with resultant sand debris spilling onto footpath at entry for subject property. It would appear that this erosion is occurring due to overland surface water flow from the southern neighboring property, the exact cause of which I was unable to determine but which is possibly associated non sealed stormwater outlet. I suggest that this issue be in the first instance taken up with the neighbor and that they be asked to rectify. Should they fail o do so I suggest that the issue be elevated to Council level.
