**Purpose of Report:** *New Unit Final Building Survey & Defects Report*  
**Date of Inspection:** 29.3.2006  
**Property Description:** **3 Bed Split Level Penthouse**  
**Address of Property:** **Unit Northcliff St Milsons Point**  
**Building Consultant:** Mr. Dominic Ogburn AMAIB Lic No BC 359  
*e-mail: [info@accesspropertyservices.com.au](mailto:info@accesspropertyservices.com.au)*  
Office (02) 9798 5000 Fax (02) 9225 9656 Mobile 0418 865-663

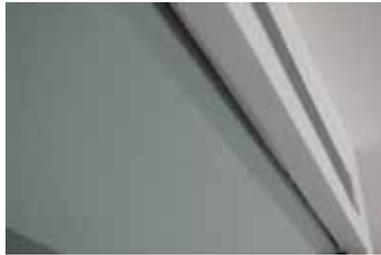
*Photo No 1*

**Bed 1;** minor differential movement cracking evident on the vertical bulkhead below NE A/C supply grille—*Refer Photo No1.*

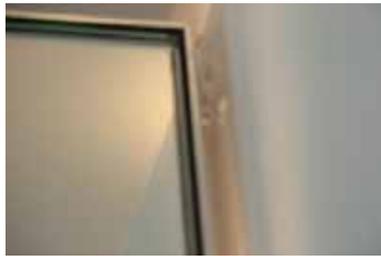
*Photo No 36*

- (2) Uneven and/ or non-matching paint coverage to the **door/ frames of *unit entry door***. Scratching evident on the external face of **B2** door jamb – ***Refer example Photo No36. B2***; inadequate paint coverage evident to the upper internal door frame.

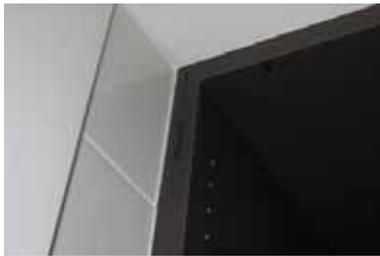
*Photo No 44*

Remove excess sealant from laundry upper linen cupboard carcass – *Refer Photo No44.*

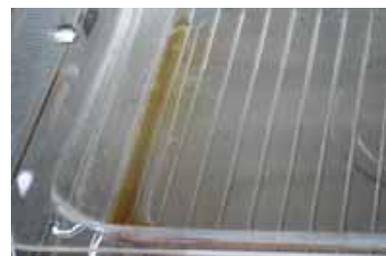
*Photo No 57*

*Refer Photo No57* of unknown oil type substance within the microwave tray- should be cleaned.

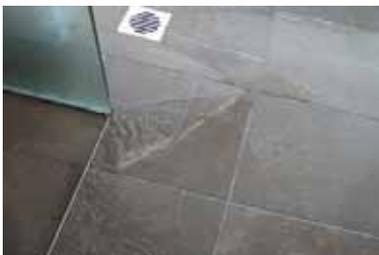
*Photo No 58*

Unenclosed shower recess allowed water to readily escape onto the main bathroom floor where it pooled—**Refer Photo No58**.

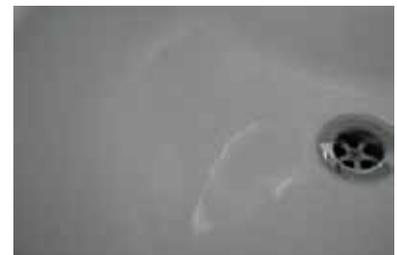
*Photo No 59A*

Internal basin bowl has evidence of scratching **Refer Photo No59A** -- rectify.

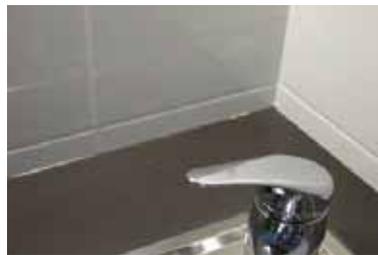
*Photo No 61A*

Sealant fill gap between laundry benchtop and splashback tiles **Refer Photo No61A**.

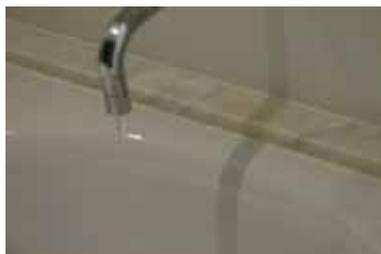
*Photo No62*

Refer prior bathroom comments regarding *inadequate flow rate* from lower floor main bathroom bath tap *Refer Photo No62*.

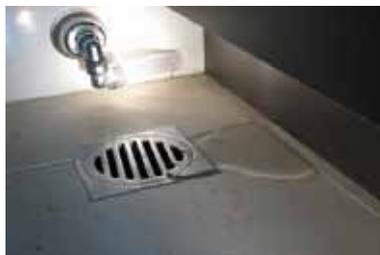
*Photo No63*

*Refer Photo No63* of an A/C *condensate line discharging onto the laundry floor* which creates a continuous to *drip noise* when the A/C is operated.

I'm not a mechanical engineer however it is my understanding that such condensate lines are to be connected directly to a waste tundish.

I recommend that the vendor provide the client with the mechanical engineers certification of as installed mechanical services and that comply with the relevant A.S and BCA requirements and that all mechanical services be inspected by an independent mechanical engineer.

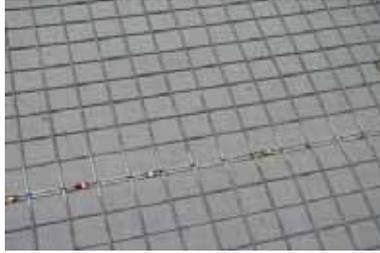
*Photo No 64*

**Color bond metal deck roof;** minor frass related surface rusting evident on upper section of roof over lightwell. *Refer Photo No64* showing significant **surface rusting** has commenced in many of the partially galvanized safety mesh covers, over the A/C plant areas and which require **rust paint rectification**.

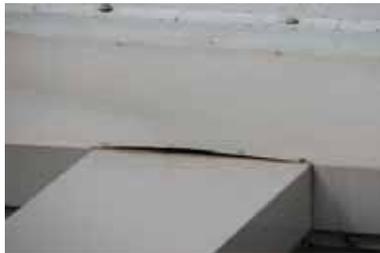
*Photo No 65*

*Refer Photo No65* of a partially dislodged metal **parapet capping** over light well, which could be allowing moisture entry and maybe the cause of previously noted damp in the walls beneath.

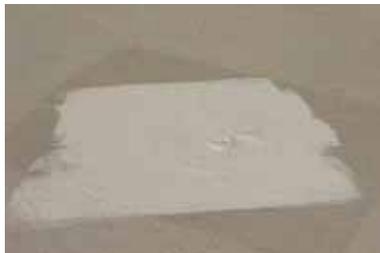
*Photo No 66*

There are many instances of prior patch repairs due to failures and/or bubbling *Refer example Photo No66*.

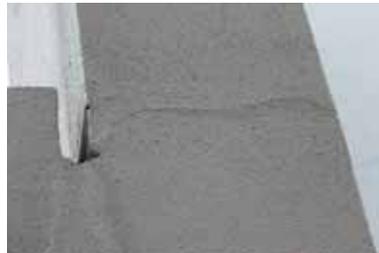
*Photo No 73*

Moisture entry has led to cracking and *render delamination* in the external wall face below Bed1 deck emergency overflow *Refer Photo No73*- rectify.

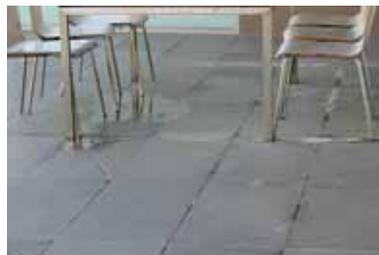
*Photo No 74*

Overnight showers had occurred prior to my inspection and when inspected excess water was significantly *ponding* in two areas of the balcony, one of which was directly beneath the external table setting. *Refer example Photos No74 & 75 and 'Lower Level Marked Up Plan' @pg 15*

I **recommend** additional access traps be installed and the area water tested to determine if substantial ponding occurs.
