## Common Area Building Survey Report

## S Aparments

The Owners Corporation  
**Strata Plan No X5YZ**

Prepared By  
**Access Property Services Pty Ltd**

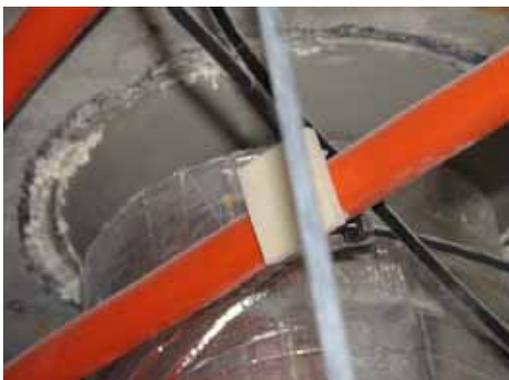
Photo No 6

**Refer example Photo No6** (taken at central ceiling access trap outside unit No1506) showing evidence of **moisture related efflorescence** staining around a seeming **roof drainpipe** penetration at the slab soffit. I tested the area with a Protimeter pin resistance type moisture meter and recorded moderate damp.

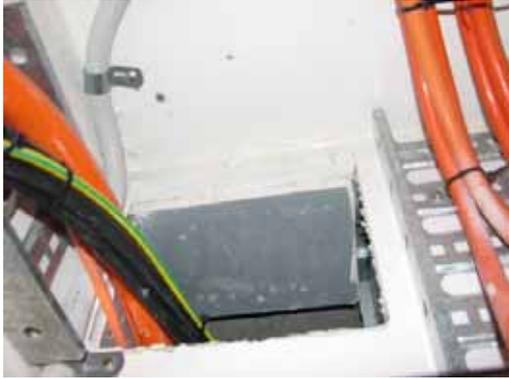
Photo No 8

**Noted Defects;** *Refer example Photo No8* of a redundant **large service cable penetration**, which does not appear to have been adequately sealed for F. R. L. It is possible that the F. R. L. rating has been compromised.

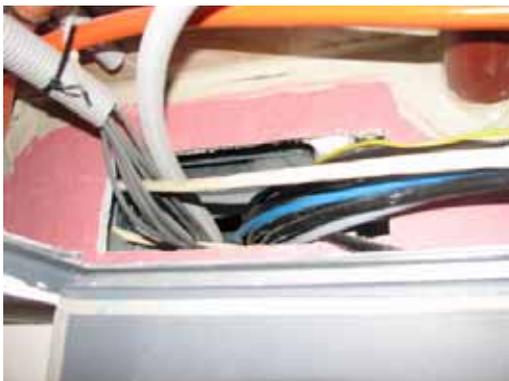
Photo No 12

**Refer example Photo No12 showing** multiple service **pipe penetrations in upper unit No 1408 separating wall**, which do not appear to have been adequately sealed for F. R. L. and STC (Rw). It is possible that the F. R. L. and STC rating of this wall are compromised.

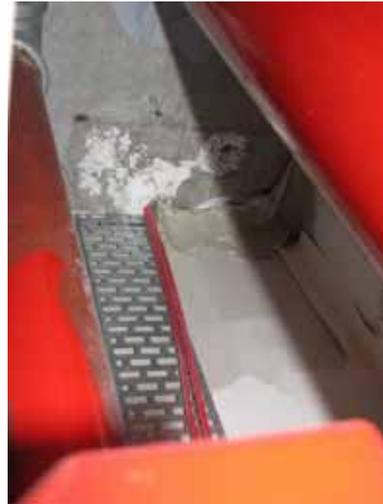
Photo No 15

**Noted Defects;** Refer example Photos No15 showing redundant **polystyrene filled service penetration** in slab soffit, which does not appear to have been adequately sealed to F. R. L. and it is likely that the F. R. L. rating has been compromised.

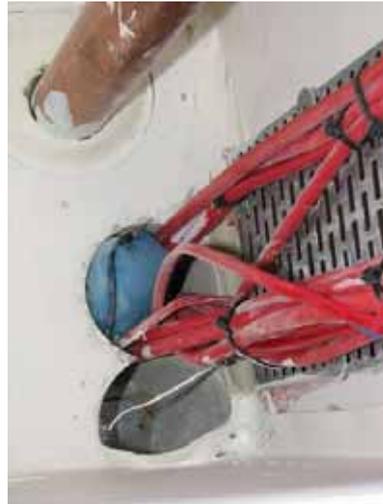
Photo No 18

**Noted Defects;** Refer example *Photo No18* showing redundant slab soffit penetration which does not appear to have been adequately sealed to F. R. L. and it is likely that the F. R. L. rating has been compromised.

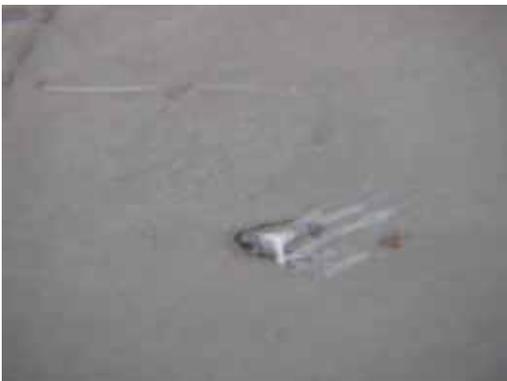
Photo No 49

**Refer Photo No49** of seeming **seepage** at the base of a **stormwater pipe** adjoining **carpark space No410**, which could be due to leakages at the pipe penetration in the slab soffit.

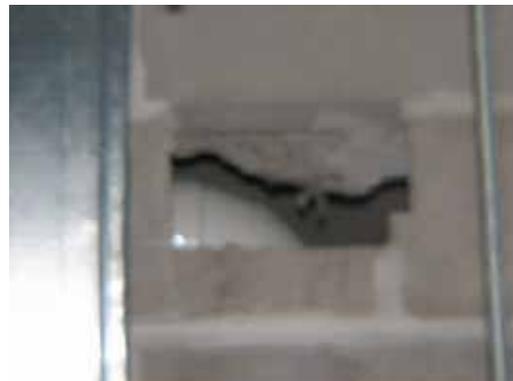
Photo No 50

**Refer Photo No50** of **seepage** related calcification stalactite (dripping) in the slab soffit over **car space No 1402**.

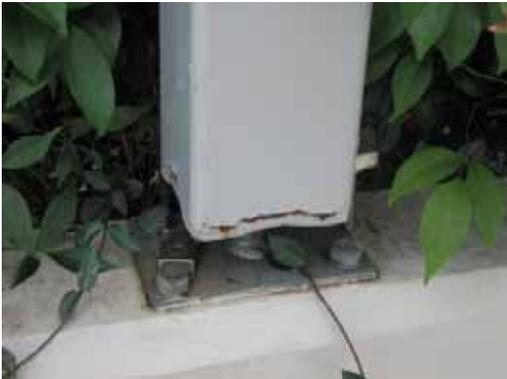
Photo No 52

The builder has installed a waterproof membrane at the junction of carpark slab and some carpark perimeter walls particularly at the western corner of Level 3 **Refer example Photo No52** and some areas of this slab have had a trafficable waterproof membrane installed however the majority of the carpark slab has not been waterproofed.

**Walkway and barbecue area;** **Refer example Photos No52 & 52a** showing evidence of early **rusting** to both the tops and/or bottoms of a number of the **painted steel pergola support posts** of both the **walkway** and **BBQ area**. Builder is to check all posts for similar rusting.

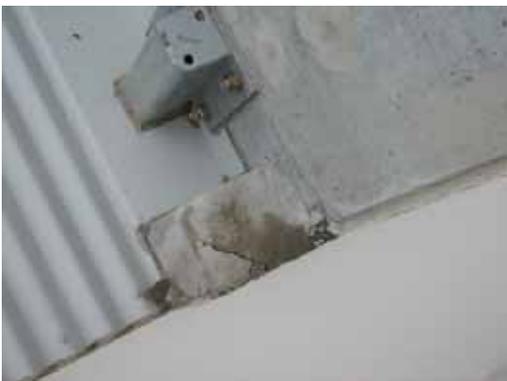
Photo No 53

**Refer Photo No53** showing evidence of **cracked delaminated concrete** atop a column abounding Woolworths store, which could be permitting falling damp.

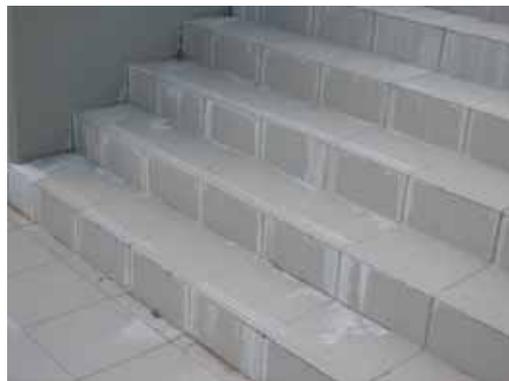
Photo No 54

**Refer Photos No 54** showing evidence of **calcification staining** in the lower tiled **stairs** abounding BBQ terrace, which is as a result of lime leaching from the tile bed and which is not generally considered a defect unless the contract had specified the additional 'Caltite' within the tile cement bed.

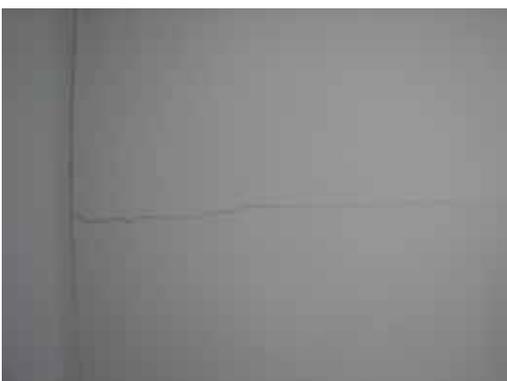
Photo No 55

**Refer Photo No55** showing evidence of **significant horizontal cracking** with associated delaminated render and which is permitting **moisture entry** in the external **Pool Plant Rm wall**.

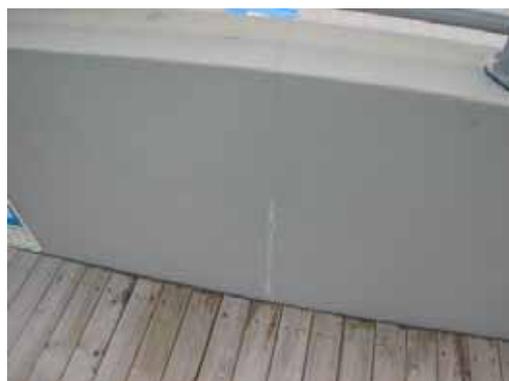
Photo No 56

**Refer Photo No56** showing evidence of **hairline cracking** and minor delaminated render, which is permitting **moisture entry** in the external **Pool SW wall**.

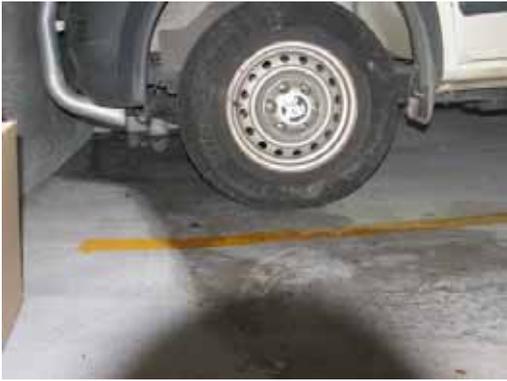
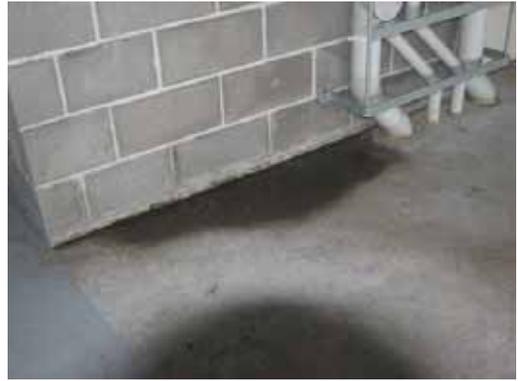
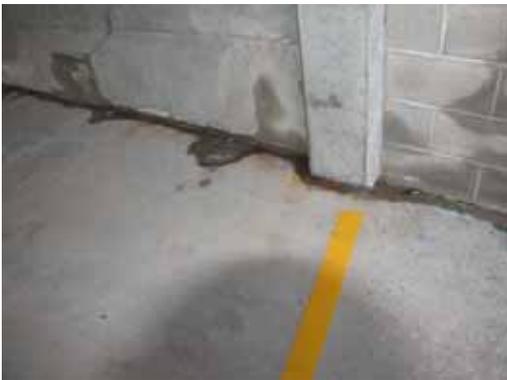
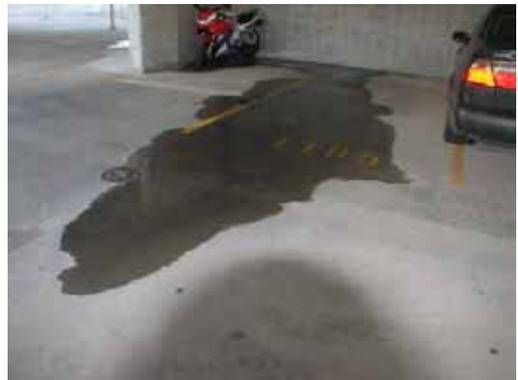
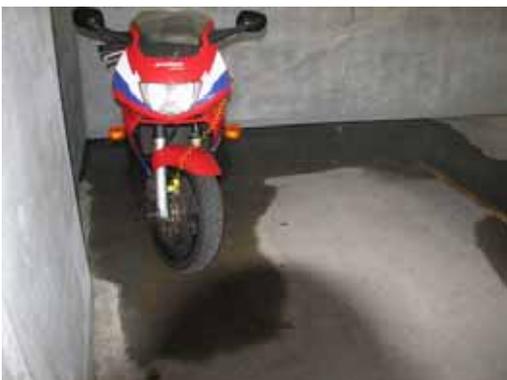
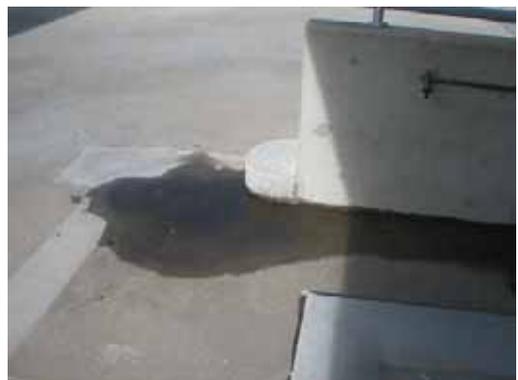
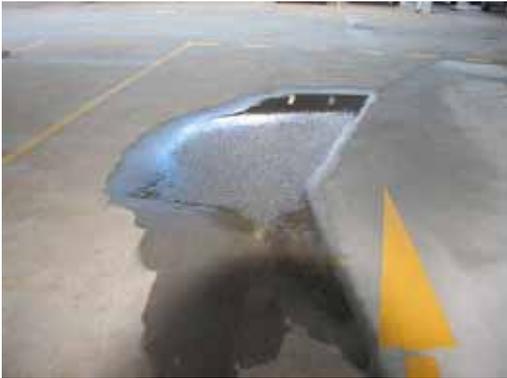
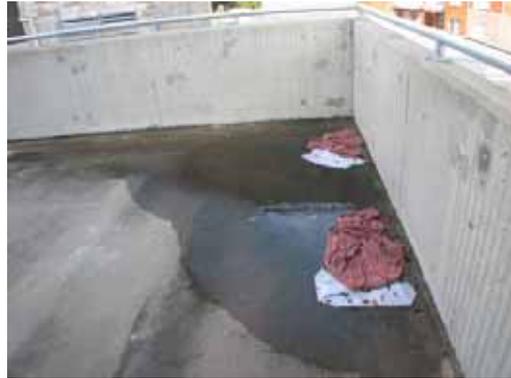
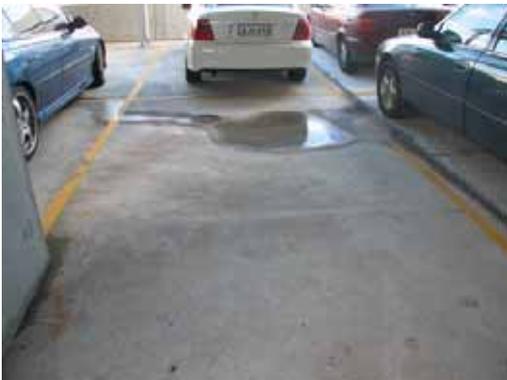
Example **locations of ponding** are at the SW carpark balustrade wall over Woolworths (i.e. negative falls), adjacent to grated drain of car space **907**, within car space **1004** and against the **adjoining stairwell door**, against the NW external wall within car space **1107** (and no waterproof membrane provision is provided), at the rear of car space **1504**, within car space **909** heavy ponding within car space **404**, at concrete **curbing adjacent to carwash area**– Refer example **Photos No57, 57a, 57b, 57c 57da, 57e, 57f, 57g & 57h**.

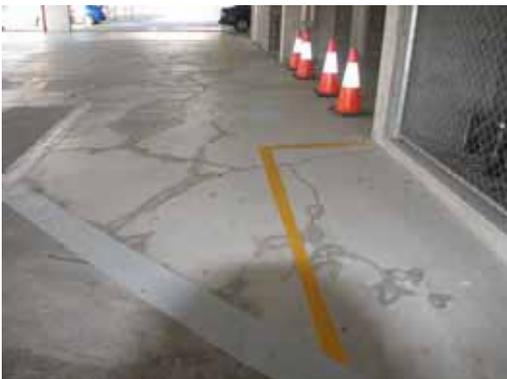
Photo No 58

Refer example **Photo No58** of sealant filled prior **cracking** within a section of carpark slab that has been previously topped (near car space **805**) together with **high moisture gain**

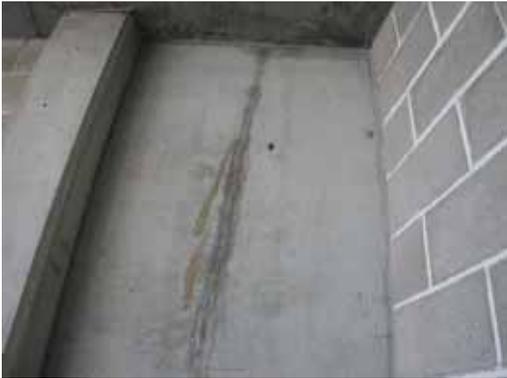
Refer **Photo No59** of evidence of **falling damp on the upper rear wall of car space No 1007** slab soffit adjacent to the carpark entry to this level and which is indicative of long-term related falling damp.

Photo No 59 (falling Level 4 carpark damp)

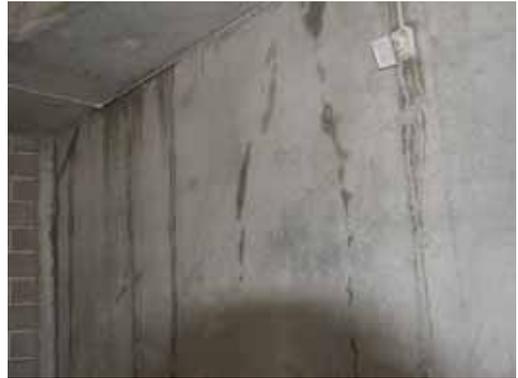
Photo No 60

Refer **Photo No60** of evidence of **falling damp on the upper external NW wall of car space No 1107** slab soffit beneath level 4, which is indicative of a failed waterproof membrane.

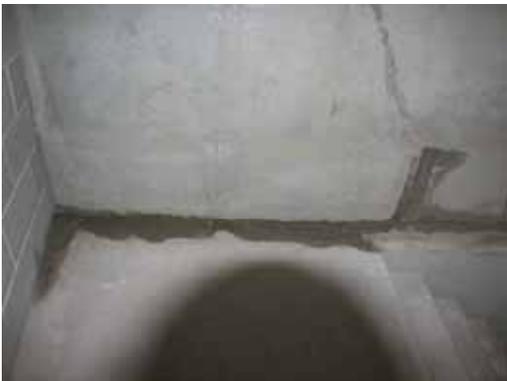
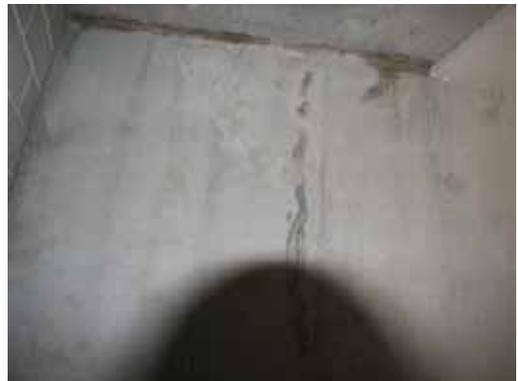
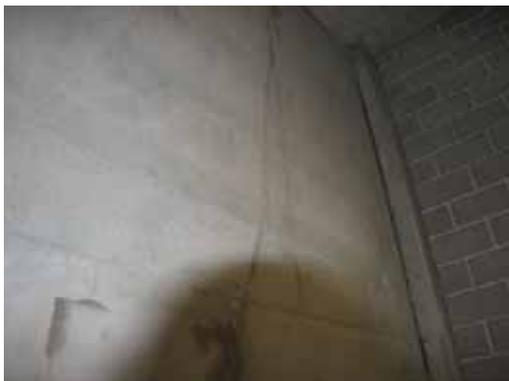
**N.W. fire stair well (Levels 3 down to 2); Refer Photo No61-61B** of evidence of **falling damp on the upper external NW wall**, which is located beneath **Level 4 planters** – Refer example **Photo No62**.

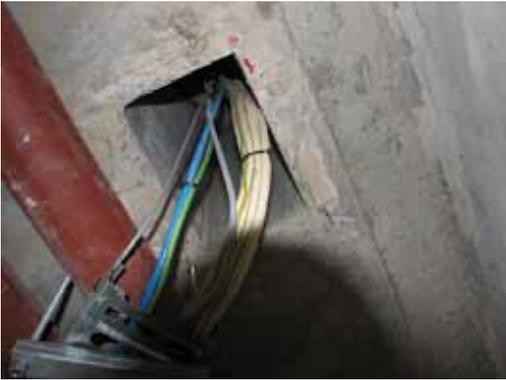
Photo No 63

Refer **Photo No63** of a large **unsealed slab soffit penetration** in the slab soffit of **car space adjacent to plant** room, which is likely to compromise F. R. L. of same.

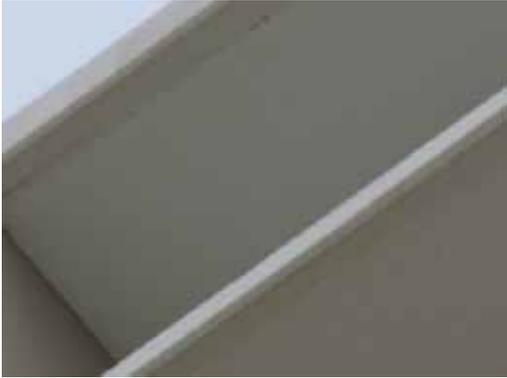
Photo No 64 (North & East corner spalling)

Such early evidence of concrete spalling is of considerable concern and the external concrete spalling will require additional close inspection to determine the extent and cause/s prior to remedial works being undertaken.

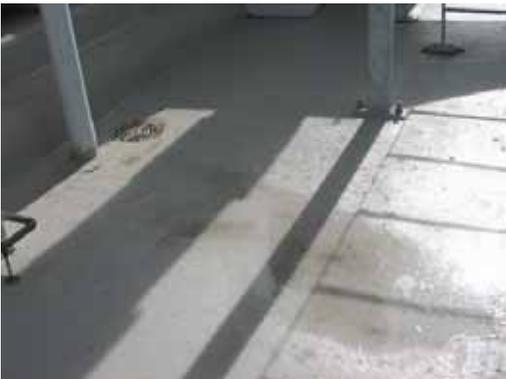
**Refer example Photos No 65A-660 of possible leakage points within the roof.**

Photo No 65 (potential roof leakage points)

**Recommendations;** I **recommend** that consideration be given to the **complete reinstatement of the roof membrane** inclusive of additional drainage particularly at the eastern and western corners and inclusive of pocket pitch type treatment of all roof penetrations.

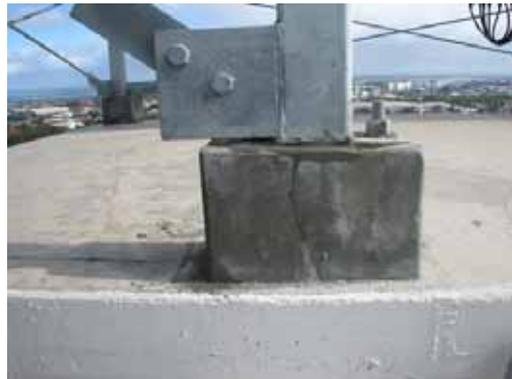
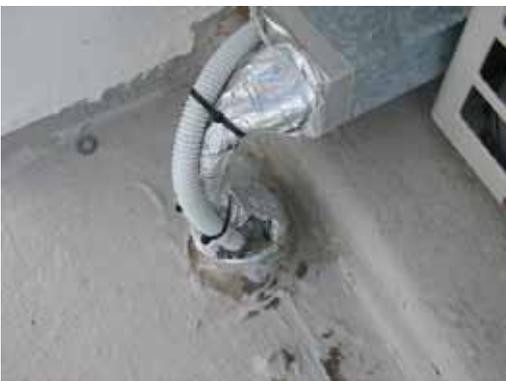
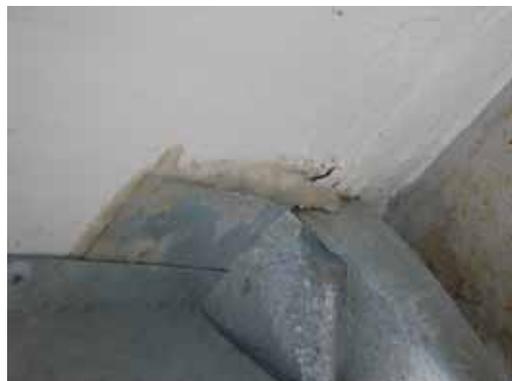
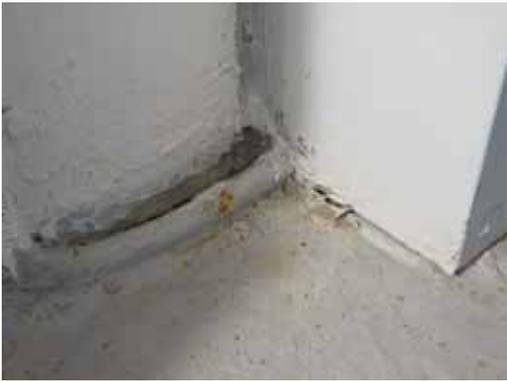
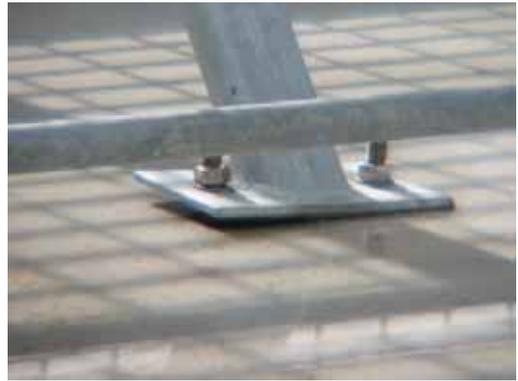
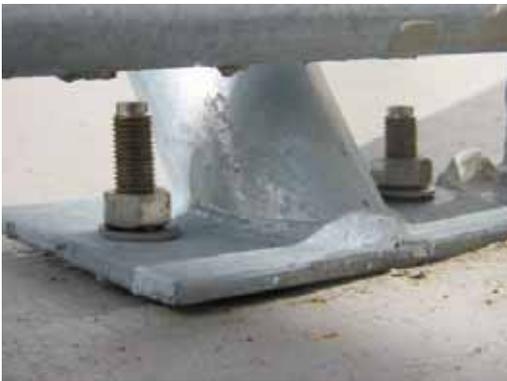
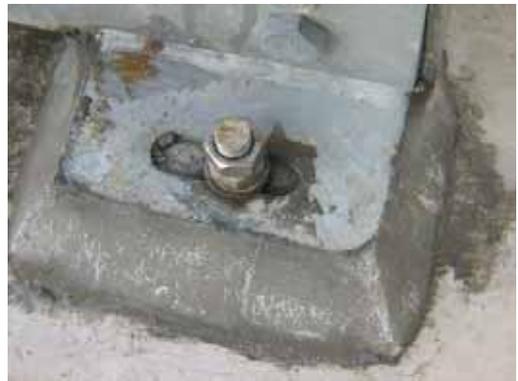
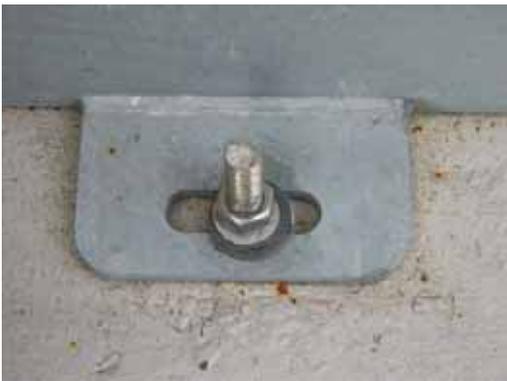
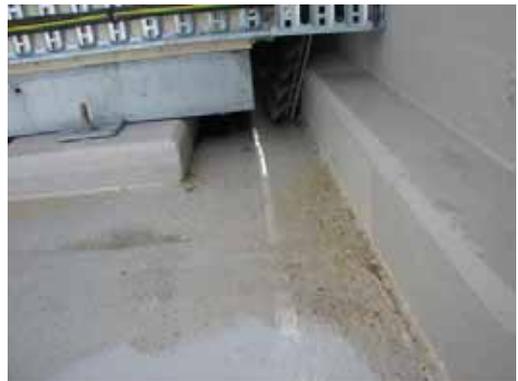
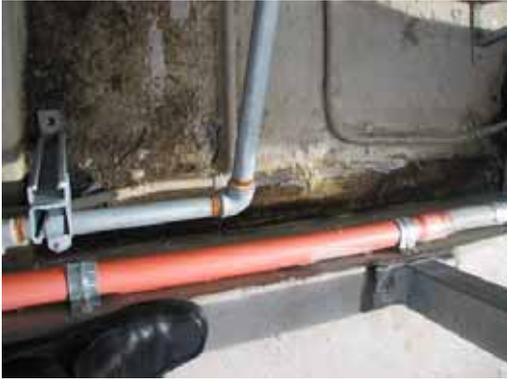
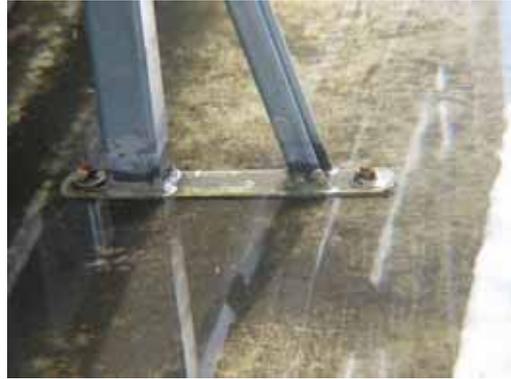
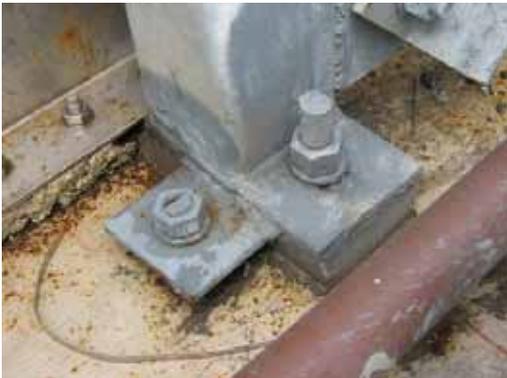
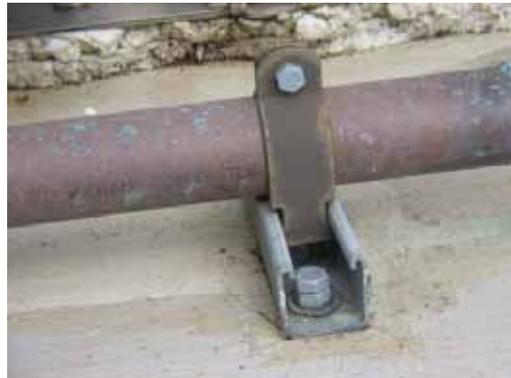
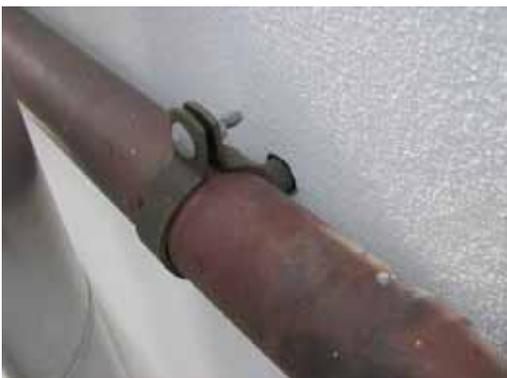
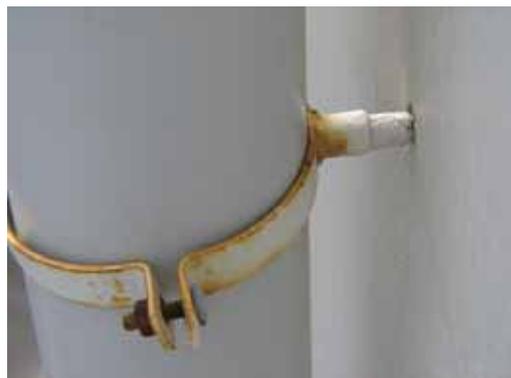
The roof slab leakages are considered highly problematic and in my professional opinion likely to require wholesale roof membrane reinstatement and in my professional opinion is most likely an issue for the builder and vendor to resolve given the seeming joint liability.

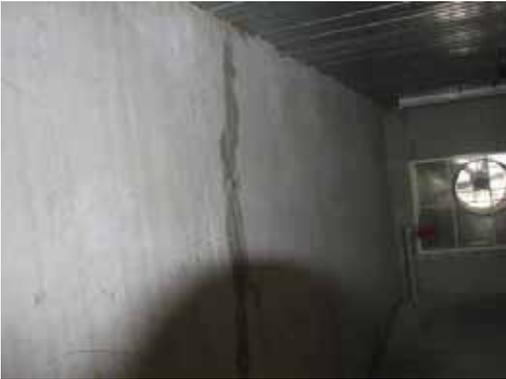
**Refer Photo No66** showing **falling damp** down at least two **internal walls of the upper fire stair well** leading to roof, located at flat concrete roof, which has at least one **telco cable tray** installed on top– **Refer example Photo No66A**, no **external slab edge drip groove** on the long the sides, some ponding **example Photo No66B** and potential moisture entry point via a **service pipe fixing/s** – **Refer example Photo No66C**.

Photo No 66 (Falling Damp Fire Stair)

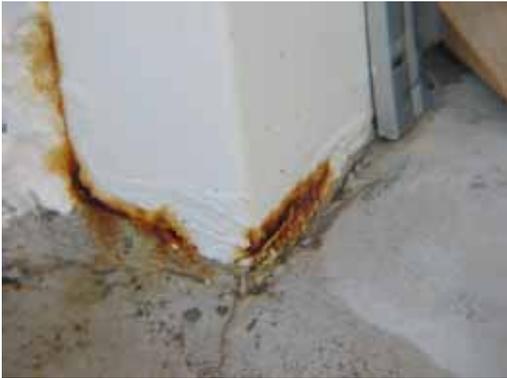
Photo No 67

**Refer Photo No67** of **rusting** to the roof access door frame and **Photo No67A** of moisture entry through the base of this door, which has occurred due to the lack of a step up and weatherproofing at base of door and also ponding of surface water in this area.

I **recommend** that a suitable waterproof hob upstand be installed beneath the roof access door.
