**Purpose of Report:** Pre Purchase Building Property Inspection  
**Date of Inspection:** 17.5.2006  
**Property Description:** 5 Bed Two Storey F.S Residence  
**Address of Property:** Bellevue Hill  
**Client Name:** Mr DW  
**Building Consultant:** Building Consultant Dominic. J. Ogburn AMAIB Lic No BC 359  
*e-mail:* [info@accesspropertyservices.com.au](mailto:info@accesspropertyservices.com.au)  
Office (02) 9798 5000 Fax (02) 9225 9656 Mobile 0418 865-663

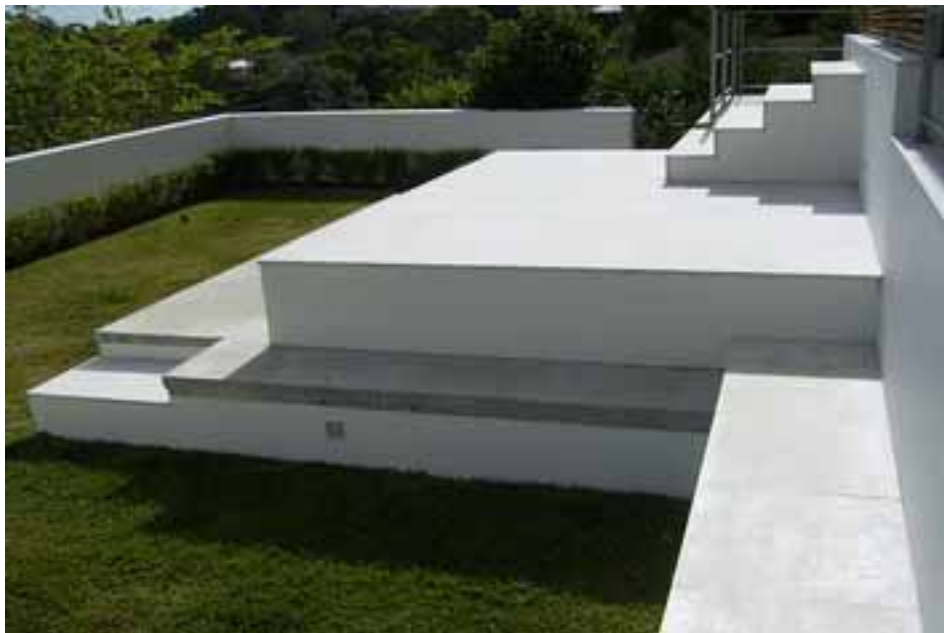
Photo No9

**Rear courtyard;** this tiled area appears to incorporate adequate falls\drainage and generally appeared quite sound. *Refer Photo No9* showing the rear courtyard steps which the client requested I provide an indicative budget estimate to remove.
